SAFETY ALERT

Loss of vehicle control – loose, damaged and broken wheel studs and nuts.

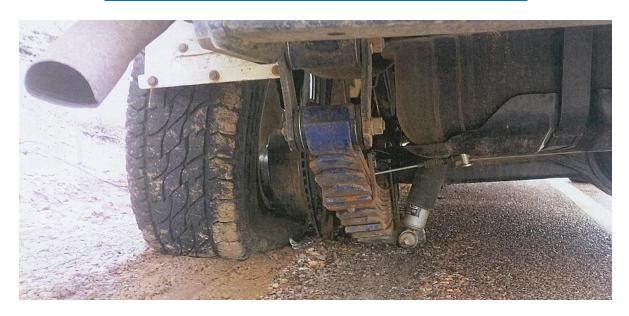
The last few months have seen a number of incidents where DEWNR employees have been put at risk due to the failure of wheel studs or nuts on the vehicles they were driving. In a number of instances the wheel assembly has separated from the axle and resulted in a serious loss of control and the vehicle leaving the road.

- 1. The driver must ensure that prior to using a vehicle a walk around visual inspection of the vehicle is made and particular care is taken to check that all wheel studs and nuts are present with no obvious signs of damage or loosening.

- 2. The Safe Driving Procedure requires (at a minimum) a monthly 'comprehensive' vehicle inspection is competed. When completing the inspection wheel studs and nuts are to be checked with a suitable tool to ensure they are tight and in serviceable condition. A <u>revised checklist</u> is now available for this purpose.

- 3. Additional care must be taken after a tyre is changed. If you change a tyre ensure that the instructions contained in the vehicle manual are followed including cleaning all mating surfaces to reduce the risk of loosening. Following servicing and or wheel/tyre repair, re-check the wheel nuts and studs after driving short distance; generally 20 to 100 metres will suffice to ensure the rim has seated correctly but the interval will depend on the conditions and use. This information and requirement should be conveyed to any subsequent drivers of the vehicle to ensure it occurs.

- 4. When driving be alert to changes in the vehicles handling or unusual noises emanating from the vehicle these could be an indicator of a loose wheel or other problems. If detected pullover promptly when safe to do so and investigate the cause.

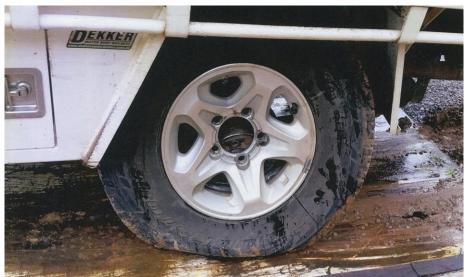
Investigations of these incidents indicate a number of factors may be in play. In a number of

instances the vehicles were 4WD and fitted with alloy rims. The recent changing or replacement of the wheel assembly also appears to be another associated factor.

imminent failure; as the studs and/or wheel nuts loosen there is a knocking noise from the wheel assembly as the rim 'wobbles' on the hub and drivers may feel a weaving sensation.
